Report Number 2517

**Evaluation of the High Sea State
Container Transfer System (HISEACOTS)
and Pontoon Air Cushion Kit (PACK)
Technology Demonstration During Joint
Logistics Over-the-Shore (J-LOTS III-91)**

April 1992

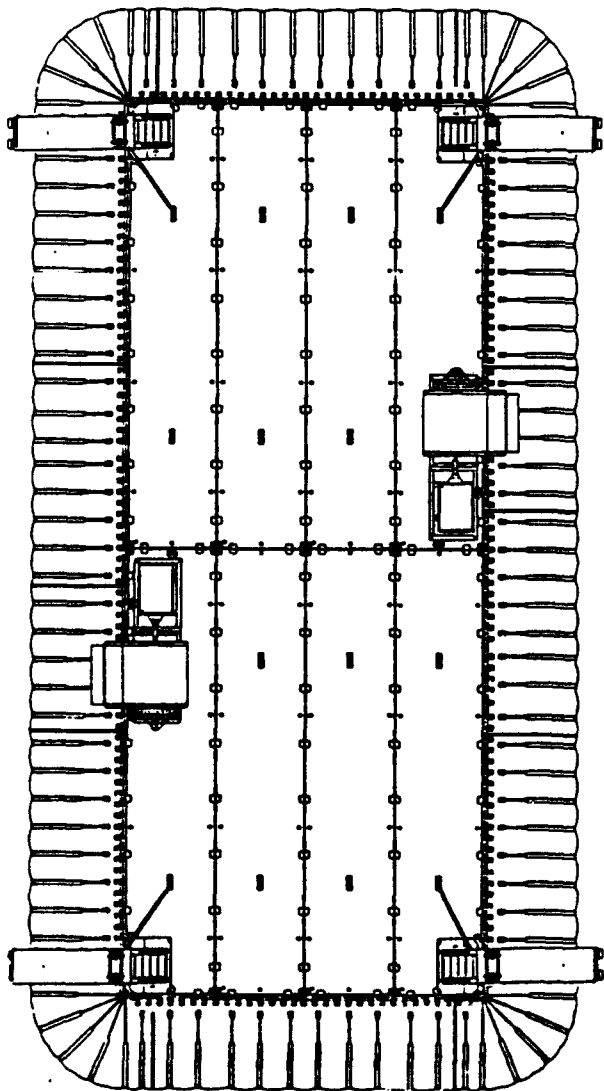
Figure 1. Pontoon Air Cushion Kit (PACK)

The PACK is designed to outfit the Army's MCS with an air cushion skirt and autonomous air-supply units that enable it to operate as an air-cushion supported platform. The PACK system can be installed on and removed from an MCS either on the deck of a ship or on land. The PACK requires no modification to the MCS; the skirt system and the air-supply units attach directly to the pontoon's locking connectors and deck fixtures. It is transportable in a commercial 40 foot open top container. The PACK is equipped with two lift-air, skid-mounted supply units that use centrifugal fans (92,000 cfm @ 150 psi) and GM 8-92TA diesel engines (350 HP). The PACK skirt system is fabricated from a 30-ounce, urethane-coated nylon reinforced material. Four steel push knees provide fendering and mooring. Army watercraft assets such as the Lighter, Air Cushion Vehicle (LACV-30), LARC-LX, and Landing Craft Utility-2000 (LCU-2000) can be used for moving the PACK-equipped MCS to the beach. The PACK technology demonstrator, tested in *Display Determination 91* and documented in this report, is shown in Figure 1. Its main characteristics are shown in Table 1.

Length Overall (LOA)	80 feet
Beam (Hard structure)	32 feet
LOA (Inflated)	97 feet
Beam (Inflated)	49 feet
Height (Hard structure)	4.5 feet
Height (On-Cushion)	11 feet
Cushion Height	3 feet
Cushion Length	85 feet
Cushion Beam	37 feet
Lightship Displacement	230,000 pounds
Full Load Displacement	490,000 pounds
Cushion Area	3,145 square feet
Cushion Peripheral Length	241 feet
Cushion Pressure (Full Load)	156 pounds per square foot
Bag-to-Cushion Pressure Ratio (Full Load)	1.15:1
Cushion Airflow	2,500 to 3,500 cubic feet per second

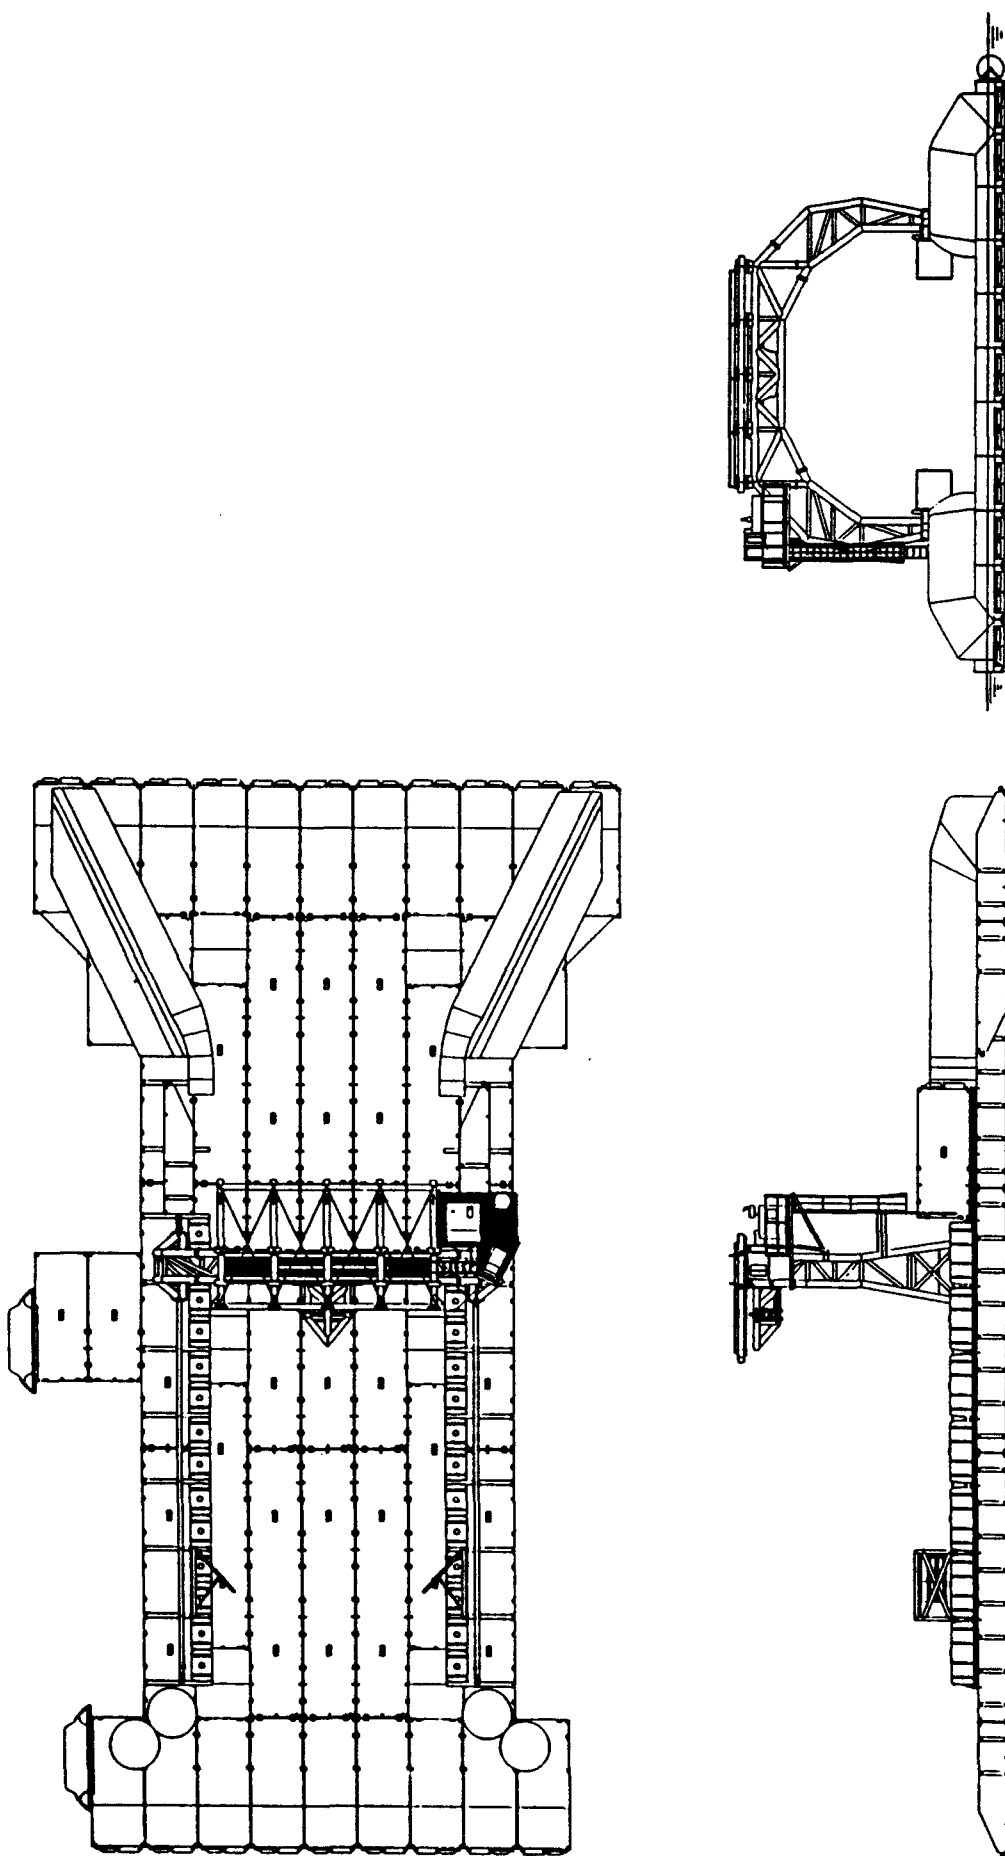
Figure 2. High Sea State Container Transfer System (HISEACOTS)

The HISEACOTS consists of a platform formed by the assembly of 8 feet wide x 40 feet long x 4.5 feet high square-end and 8 feet wide x 20 feet long x 4.5 feet high raked-end modular pontoons currently being added to the inventory. This platform is securely moored alongside the T-ACS and provides a stable landing platform for the Lighter Air Cushion Vehicle-30 Ton (LACV-30) during offload operations. The platform utilizes inverted raked-end modules as ramps, which allows the LACV-30 to fly onto the platform at

one end and off from the other. The platform is fitted with batterboards and arresting gates to safely guide and align the LACV-30 onto the platform during high sea state operations. The platform is outfitted with a specially designed traversing gantry crane that accepts the transfer of a container from the T-ACS crane and then spots and lowers the container to the deck of the LACV-30 without problems associated with pendulation or relative motion. The HISEACOTS technology demonstrator, as tested during *Display Demonstration 91* and documented in this report, is shown in Figure 2. Its main characteristics appear in Table 2.

Overall Length	160 feet
Entrance Ramp Beam	88 feet
Exit Ramp Beam	72 feet
Middlebody Beam	56 feet
Fly-Through Width	40 feet
Overall Height	41 feet (Gantry: 36.4 feet)
Entrance Freeboard	22 inches
Exit Freeboard	34 inches
Weight (Light)	513.4 short tons
– Gantry Crane	13.4 short tons
– Platform	500 short tons
Full Load Weight	593 short tons (w/LACV-30 + one 22 short ton container)
Gantry Crane Design Capacity	25 short ton container
Pendulation Limits	+15 feet lateral displacement –15 feet lateral displacement
Heave Limits	+5 feet vertical displacement –5 feet vertical displacement

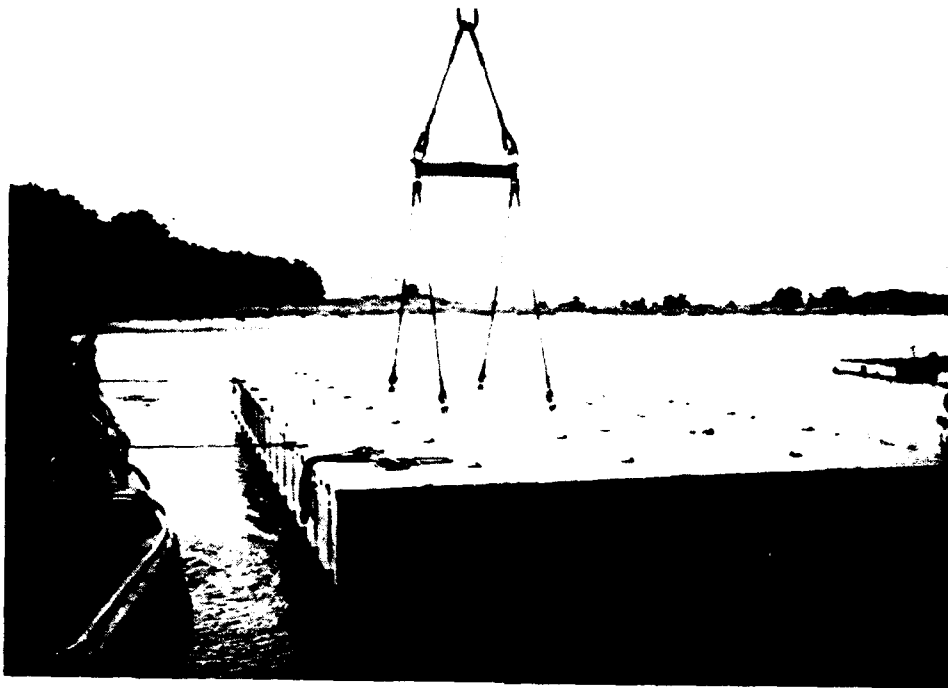
Photo 1

The PACK was assembled at Fort Eustis, VA, 3rd port area, 12-16 August 1991. We connected its modular platform (80 feet long x 32 feet wide) in the water, taking approximately 3 hours, and lifted it onto the hardstand area using the 100-ton capacity barge crane (Photo 1).*

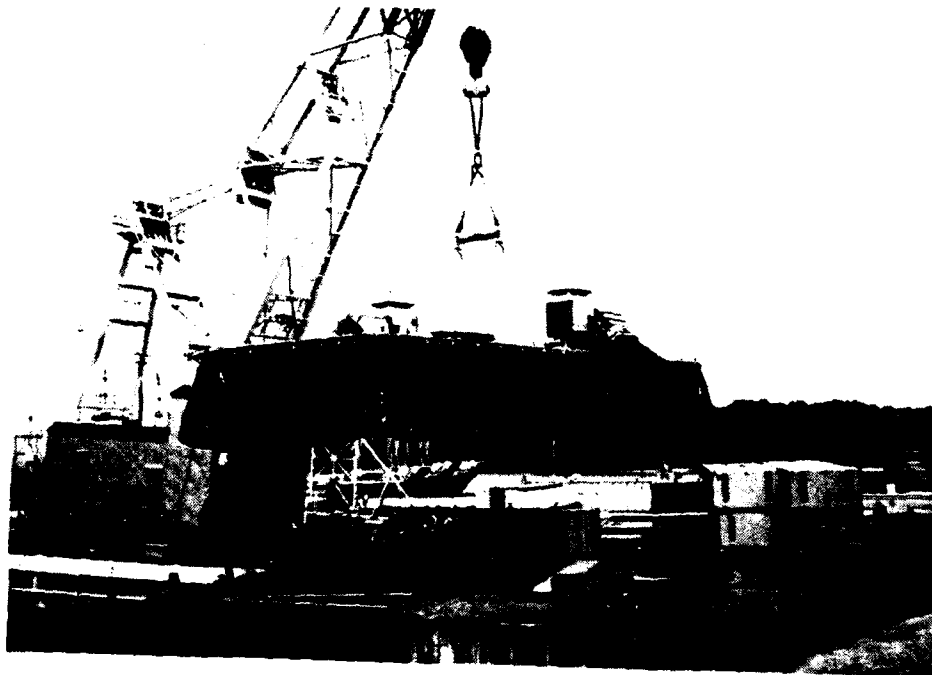
Photo 9

winches made connecting the fan duct relatively easy. We split the duct into two pieces for ease of handling and transportation. The worm-gear winches made it possible for a one-man installation (Photo 8). It took 90 minutes each to install the two-part duct. We sealed the modular platform joints with a commercially available foam. Foaming the entire platform took approximately 3 hours which included drying time. The PACK was lifted into the water, without push knees, using a specially designed lifting sling assembly (Photo 9).

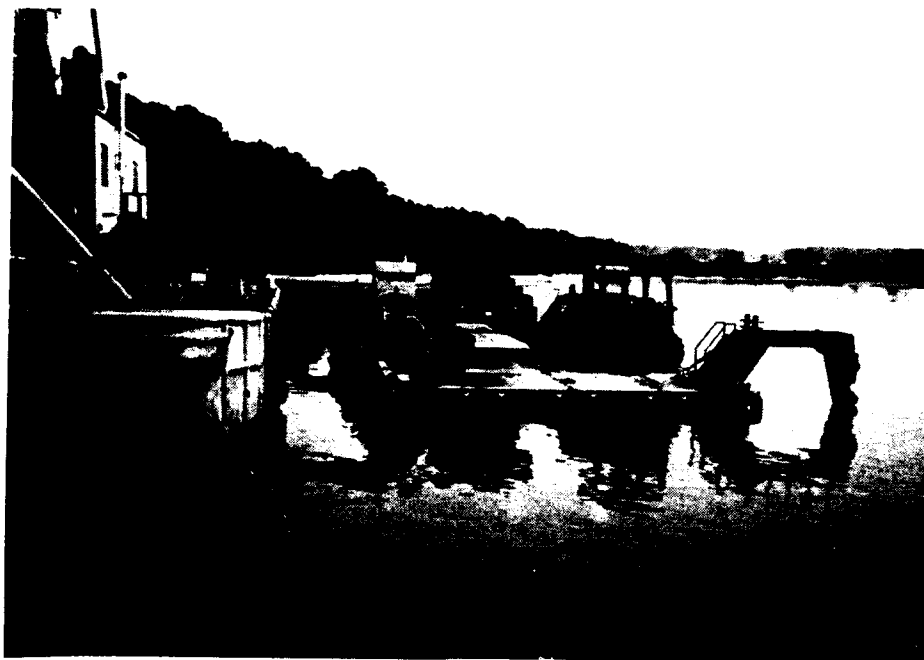
Photo 17

On 23 August, we loaded a D-7 bulldozer, RTCC, and the portable beach ramps onto the PACK (Photos 16 and 17) at Fort Eustis. An LCM-8 towed it from the 3rd port to the James River channel where a pair of LACV-30s took the hand-off (Photos 18 and 19) and pushed the PACK to Anzion Beach, approximately 1 nautical mile (Photos 20 and 21). There, the RTCC offloaded the beach ramps from the PACK, allowing for the discharge of both vehicles (Photos 22, 23, and 24). The D-7 then proceeded to tow the PACK onto the beach.

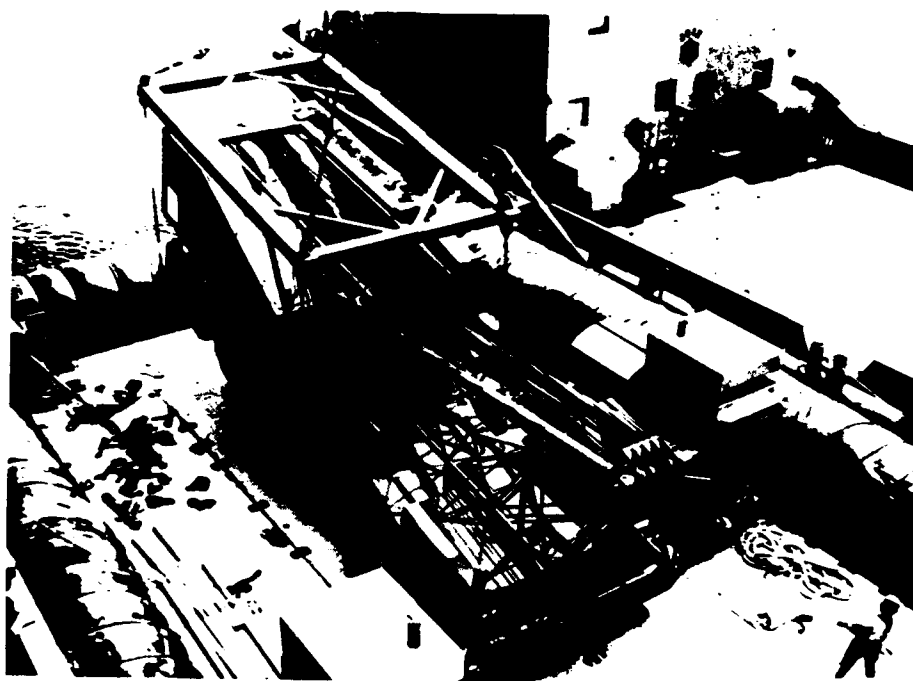
Photo 27

On 17 September, a 140-ton capacity beach crane, with base boom section and one counterweight, was loaded onto the PACK (Photo 27). The estimated weight of the basic carrier (with front bumper counterweight) and the "A" counterweight was 58 short tons. Once loaded onto the PACK, the beach crane was driven forward to trim the craft. We used an LCU-2000 to tow the PACK with the beach crane to the Amphibious Discharge Site for transfer to a LARC-LX (Photo 28). The LARC-LX towed the PACK onto the beach for discharge (Photo 29). The LARC-LX experienced some difficulty while continuing to tow the PACK inland to the desired offload site. The PACK skirt system was not sealing properly and the craft was not trim. It is estimated that two complete fingers were missing and approximately 20 air gaps in the finger harnesses significantly reduced the hover height which was exaggerated by the uneven trim condition. However, despite this air loss and trim condition, the LARC-LX was able to pull the PACK to the beach for discharge and further inland to the crane discharge site. The 140-ton capacity beach crane (with outriggers) was offloaded using the PACK's portable beach ramps (Photo 30). Repairs were completed on the beach using old PACK skirt fingers and stitching and riveting where required.

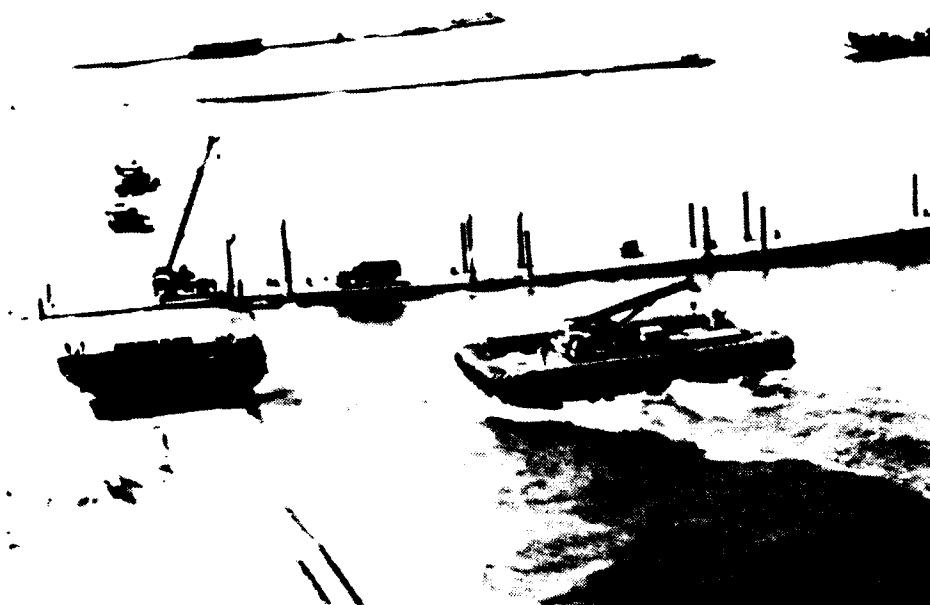
Photo 32

The PACK continued to demonstrate its heavy lift capability during the J-LOTS III exercise. Other vehicles carried by the PACK included: two M1A1 tanks (128 tons); one RTCC with ramps (64 tons); and one RTCC with D-7 bulldozer and PACK beach ramps (90 tons) (Photos 31 and 32).

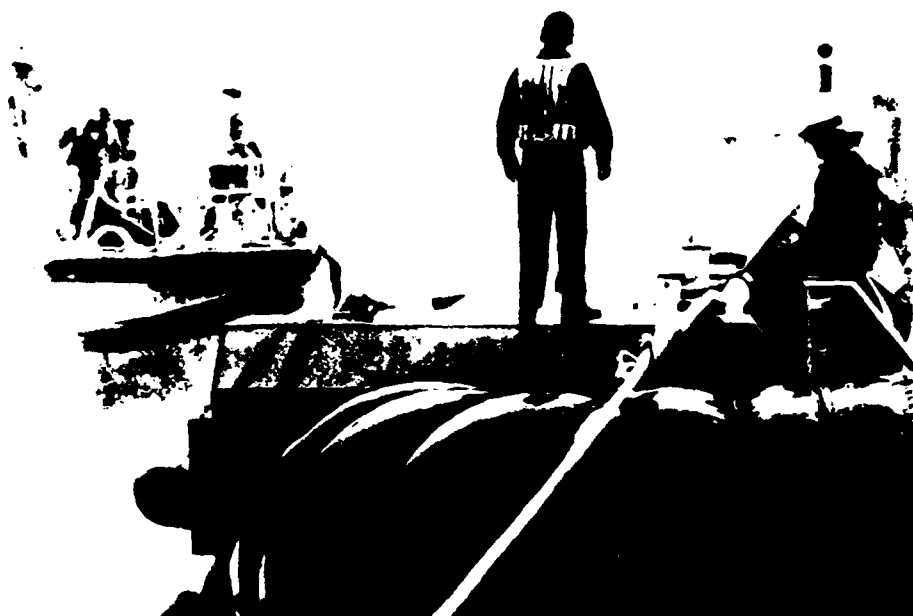
Photo 34

On 25 September, The US Navy Landing Craft Air Cushion (LCAC) towed the PACK, which was loaded with the RTCC, D-7 bulldozer, and beach ramps (Photos 33 and 34). The LCAC was moored beam-on to the PACK for the demonstration. It produced a large amount of spray during the tow and maintained a much higher cushion flow rate than necessary. As a result, the LCAC produced excessive amounts of spray that collected on the deck of the PACK. The PACK had to be brought off-cushion once in order to drain off the water. The LCAC operator was not trained for this type of mission and was very slow and deliberate when maneuvering the PACK. The LCAC pushed the PACK at about 3 to 4 knots. In addition, communication with the LCAC operators from the PACK deck, using hand-held marine radios, was very difficult because of high noise levels.

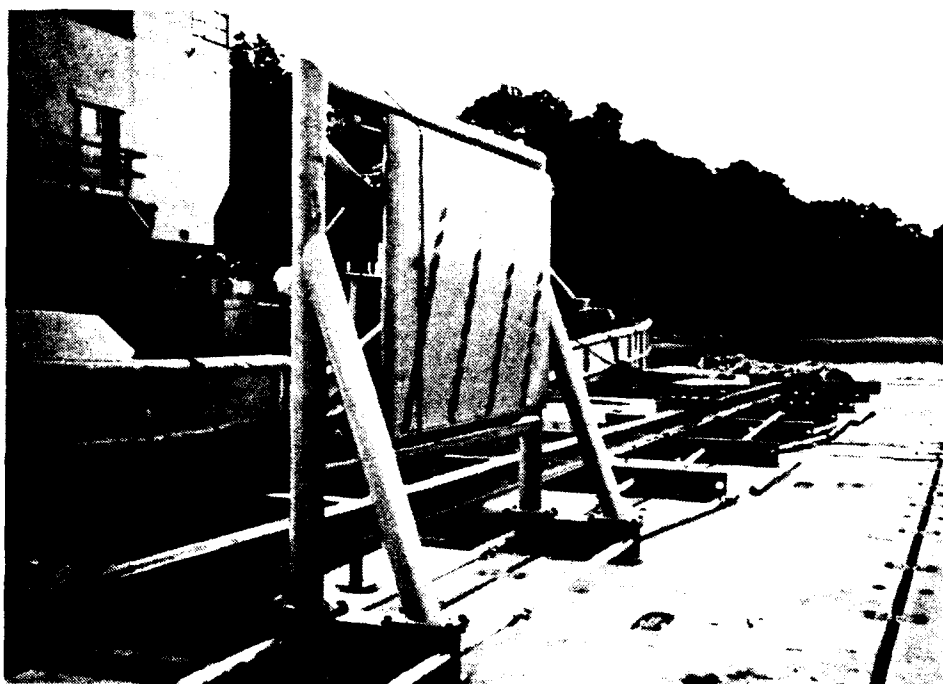
Photo 48

Two arresting gates (8.5 feet high x 10.5 feet wide) were bolted to transverse rails on both sides of the platform (Photo 48). The gates are passively operated by a self-contained hydraulic system (Photo 49). The gates position the LACV-30 and stop it when a container is prepositioned on the gantry's spar. The gates are normally in an extended position unless closed by an LACV-30 high pressure fender. (Photo 50) Return springs open the gates to their fully extended position (Photo 51).

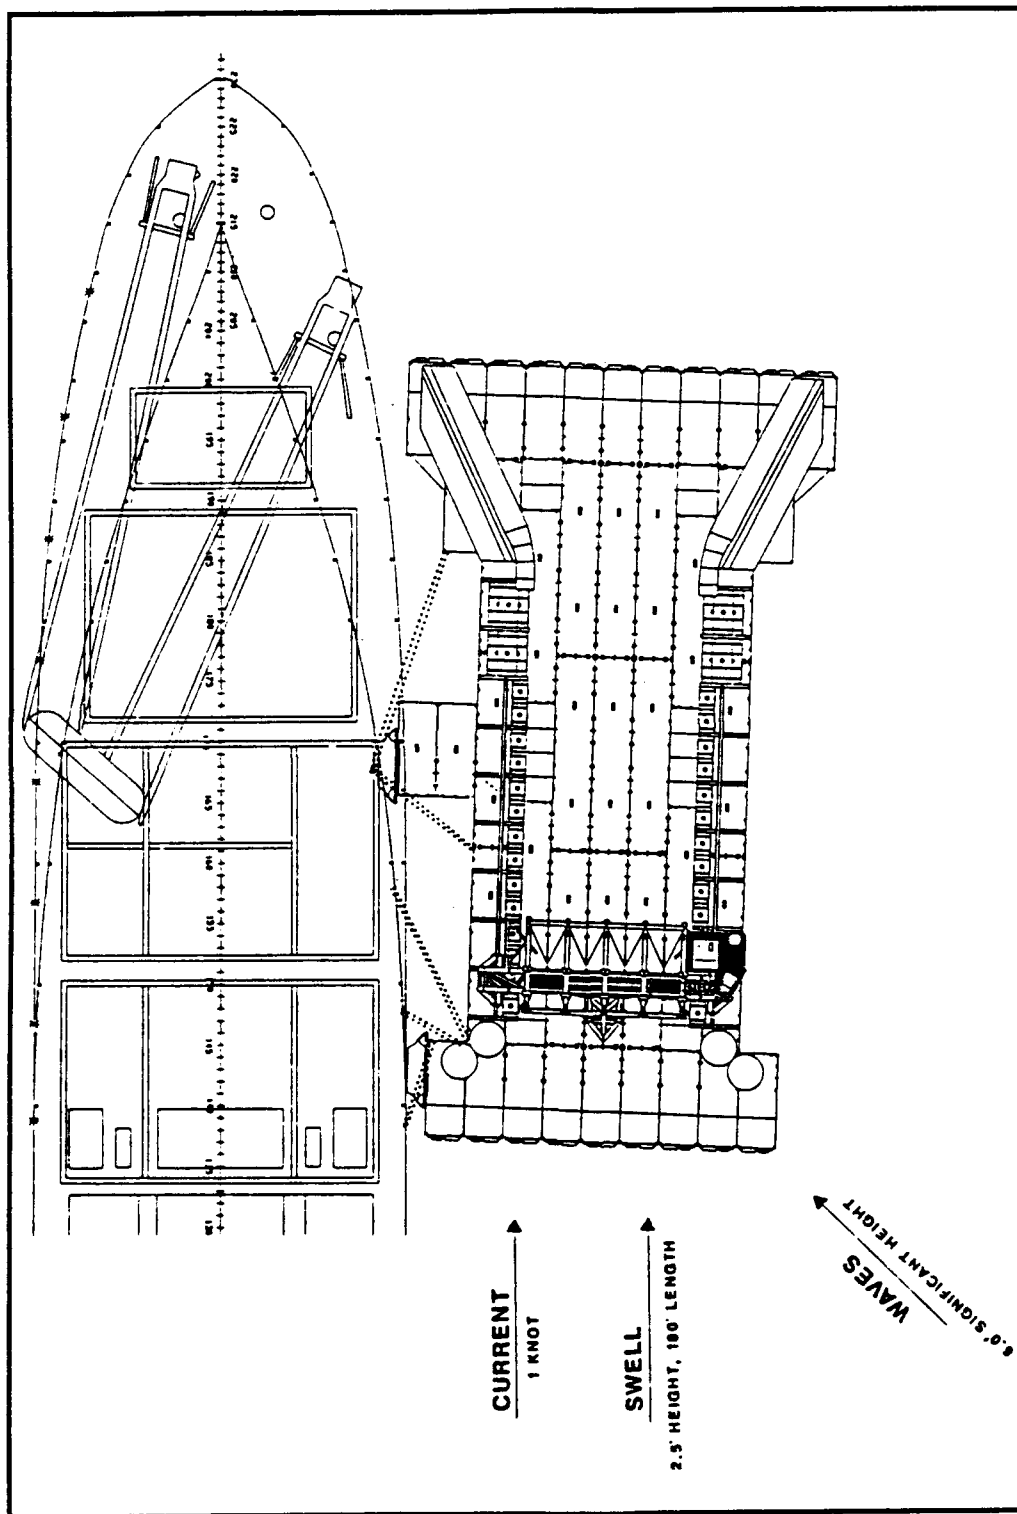
Figure 1. Mooring Arrangement and Sea Conditions

The mooring arrangement of the HISEACOTS at the time of the incident is shown in Figure 1. Also shown in Figure 1 are the estimated wind, wave, current and swell conditions just prior to the platform failure.

Sea conditions during the storm, and particularly alongside the T-ACS ship, were most probably more severe at some point in time than those assumed in Figure 1. Another possible load would be a "suspension" of the forward inboard platform corner by the mooring lines under severe pitch motions, however,

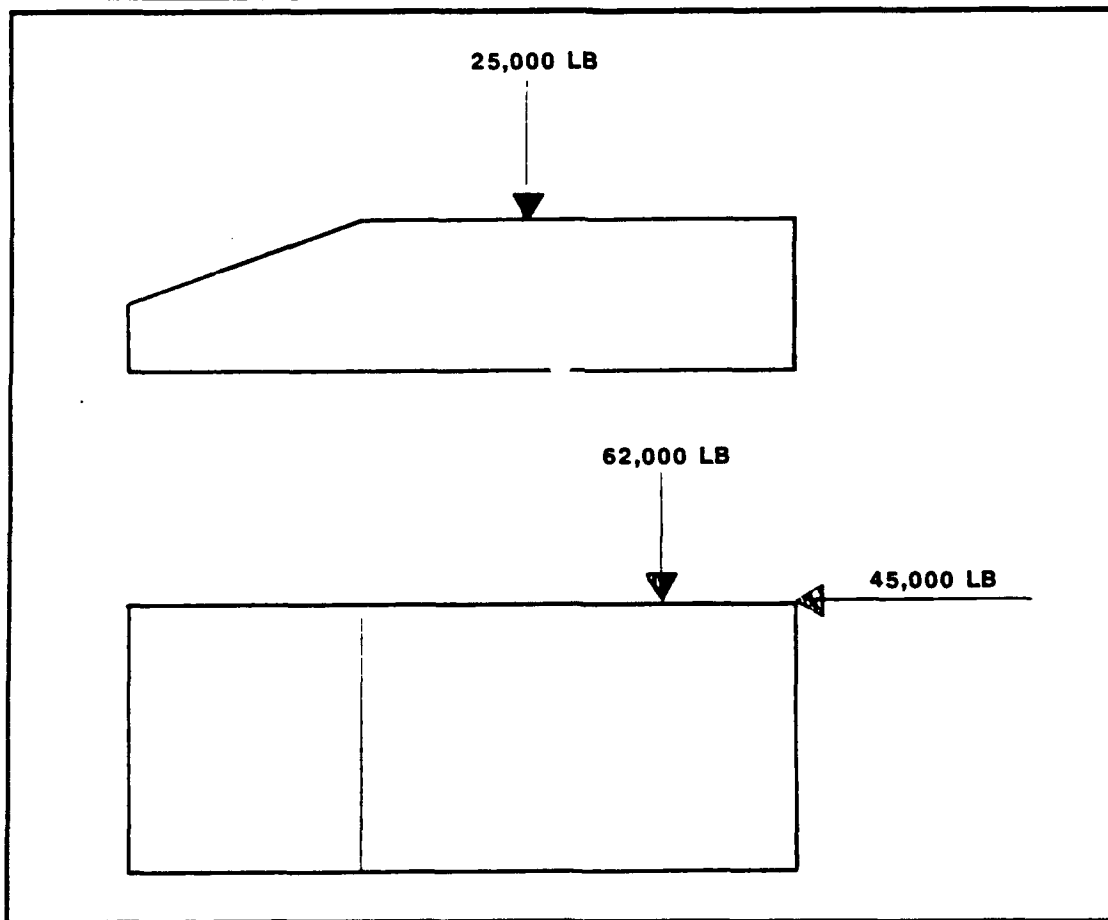
Figure 3. Loads Acting on Forward Inboard Fender Module

For the purposes of this analysis, it is presumed that all surge and sway forces were reacted on the forward fender module as shown in Figure 3. An additional load on this module was the weight of the departure ballast tanks, fully supported by the connectors as the platform end pitched free of the water. As seen in Figure 1, an additional spring line was rigged to resist sternwards surge. However, this longer line was more difficult to tension than the shorter forward spring line, and could stretch significantly more under a given load. Thus, it probably contributed little to reacting the surge loads. The forward fender was likely to have seen the full sway load at times.

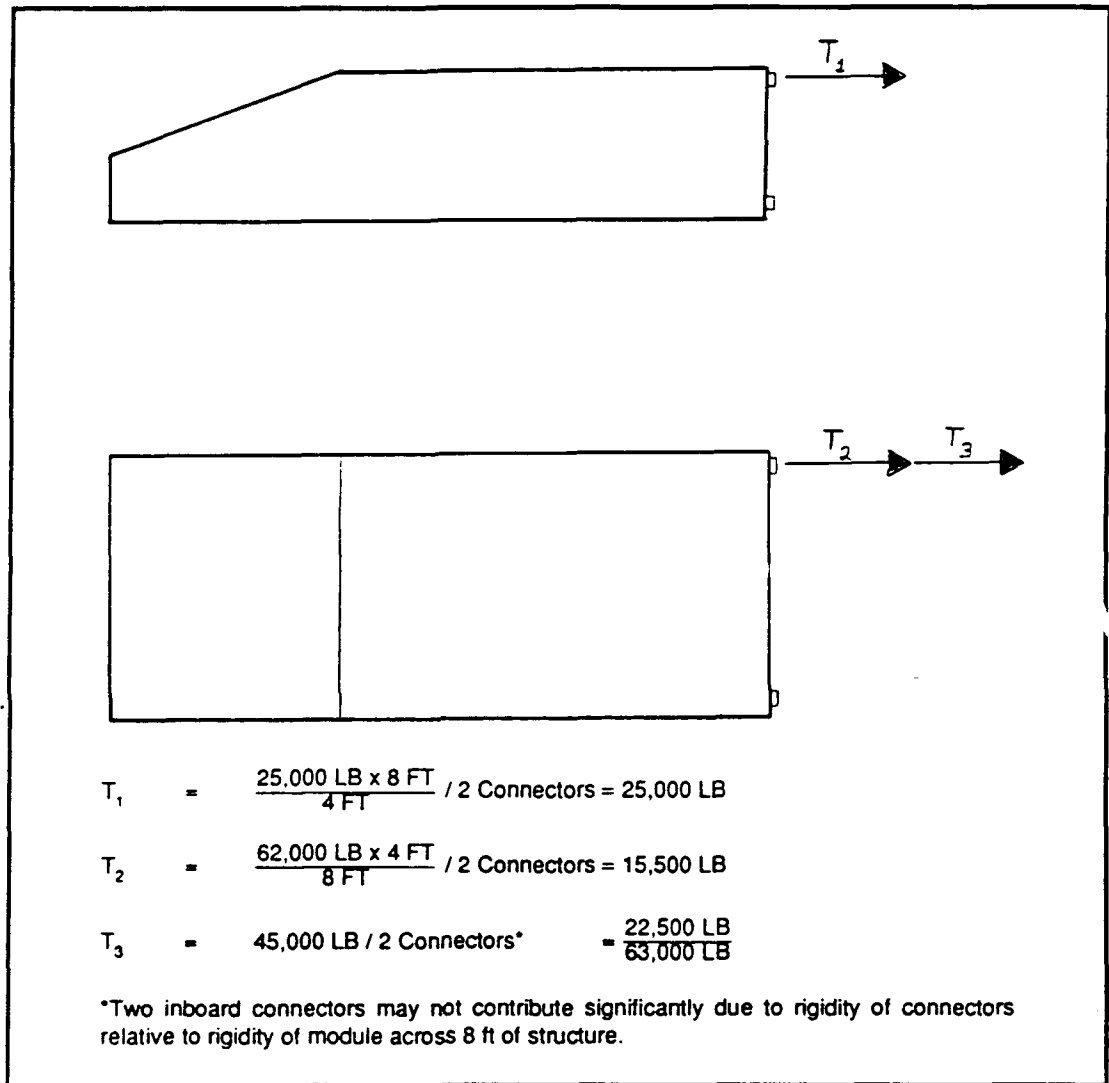
Figure 4. Tensile Loads in Upper Inboard Connector of Forward Fender Module

A diagram of the probable worst-case loading on the upper inboard connector between the second-to-inboard ramp module and its adjacent module is shown in Figure 4. The connectors between the inverted raked-end 20-ft modules and the 40-ft module were designed and fabricated to bolt ISO corner-to-ISO corner. The necessity to invert the 20-ft module to form a ramp-end precluded use of the standard Isolog pin and guillotine connectors. Due to the presence of some play in the design of the Isolog connectors fastening adjacent 20-ft modules, it is reasonable to assume that these rigid connectors reacted the majority of the mooring loads.

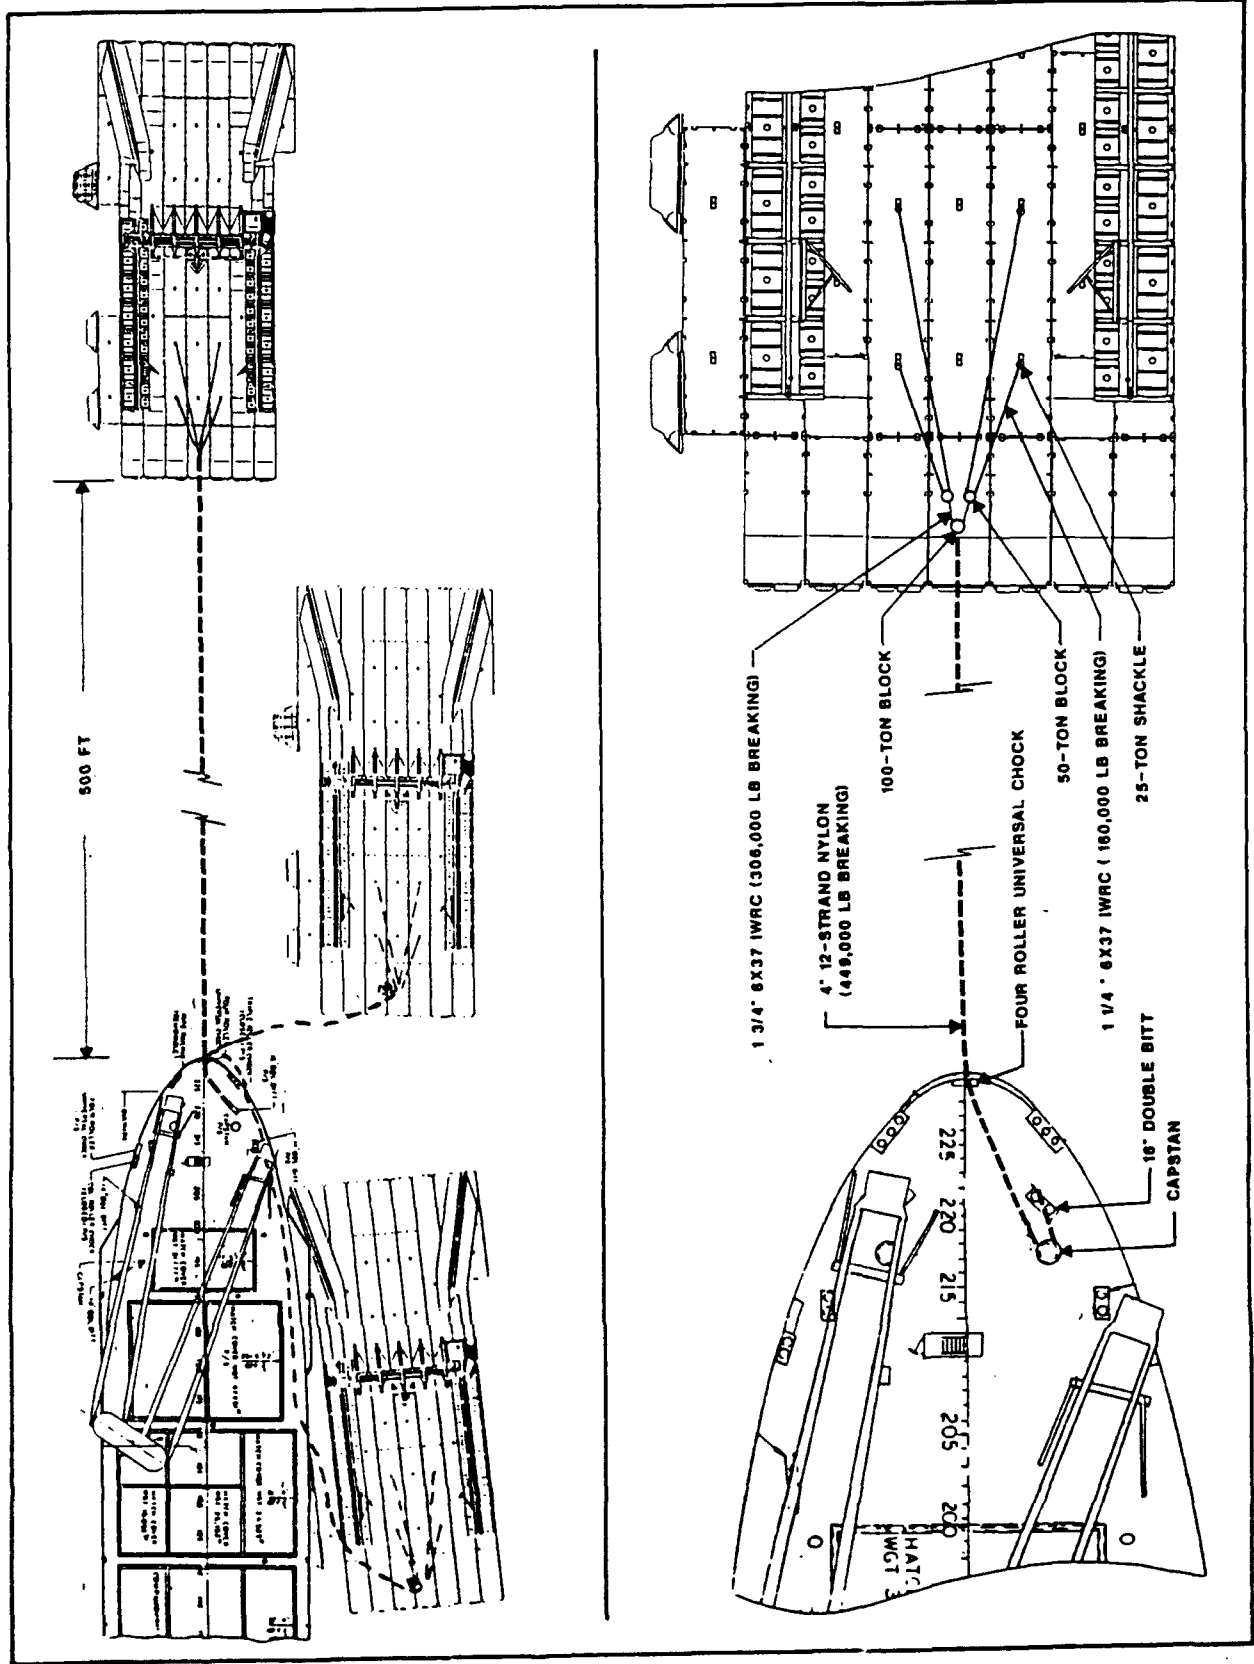
Figure 7. Emergency Mooring System

An emergency mooring system will also be provided to allow for HISEACOTS survival in sea states through sea state 6. The probable arrangement of this system is shown in Figure 7. The system will be designed for readily deployment with either the T-ACS ship or an anchoring system serving as the mooring point.
